AFRL-PR-WP-TR-1998-2119

Investigation of TESCOM Driveshaft Assembly
Failure

Technology Evaluation Branch
Turbine Engine Division

October 1998

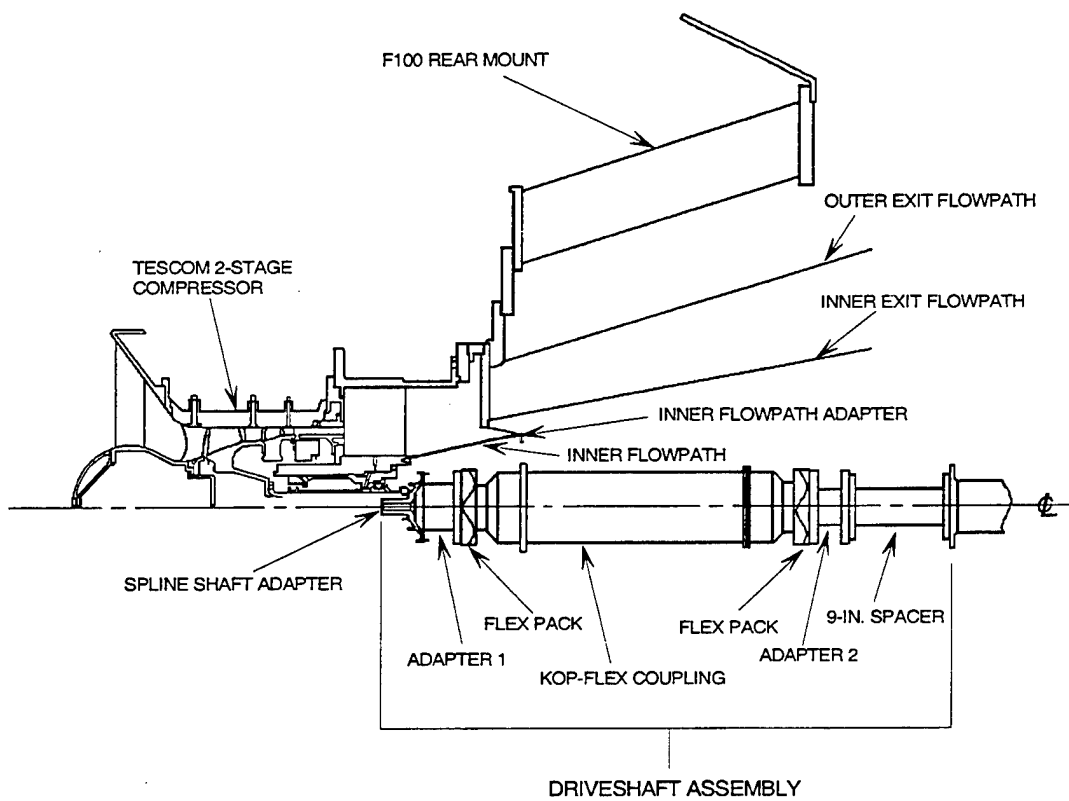
Figure 1.5. TESCOM driveshaft assembly.

The compressor drive system consists of the driveshaft assembly and the balance piston. The compressor drive system is shown in more detail in Figure 1.5. Several new drive system components were required to adapt the test compressor to the CRF drive system. These new components included adapter 1, between the spline shaft adapter and the forward flex-pack, as well as the Kop-Flex coupling spacer between the flex-packs. Upon assembly of the rig in the chamber, it was determined that the compressor driveshaft assembly was 9 inches too short to connect to the CRF main driveshaft. To

alleviate this disparity, a 9-inch spacer was fabricated and installed between adapter 2 and the CRF jackshaft. The effect of this additional spacer on drive system dynamics was not determined prior to testing.

The driveshaft assembly also serves as the wireway for lead wires to blade-mounted instrumentation on the test compressor. For TESCO, this consisted of strain gages on rotor 2 blades. The lead wires from the strain gage were passed through the hollow center of the driveshaft assembly. A foam filler was sprayed into the hollow areas of the driveshaft assembly to hold the strain gage leads in place along the centerline of the assembly.
